## **TD Environmental**

Subject: **Onsite Inspection Report**

135 Rusty Nail Dr

IAQ Findings and Remediation Plan

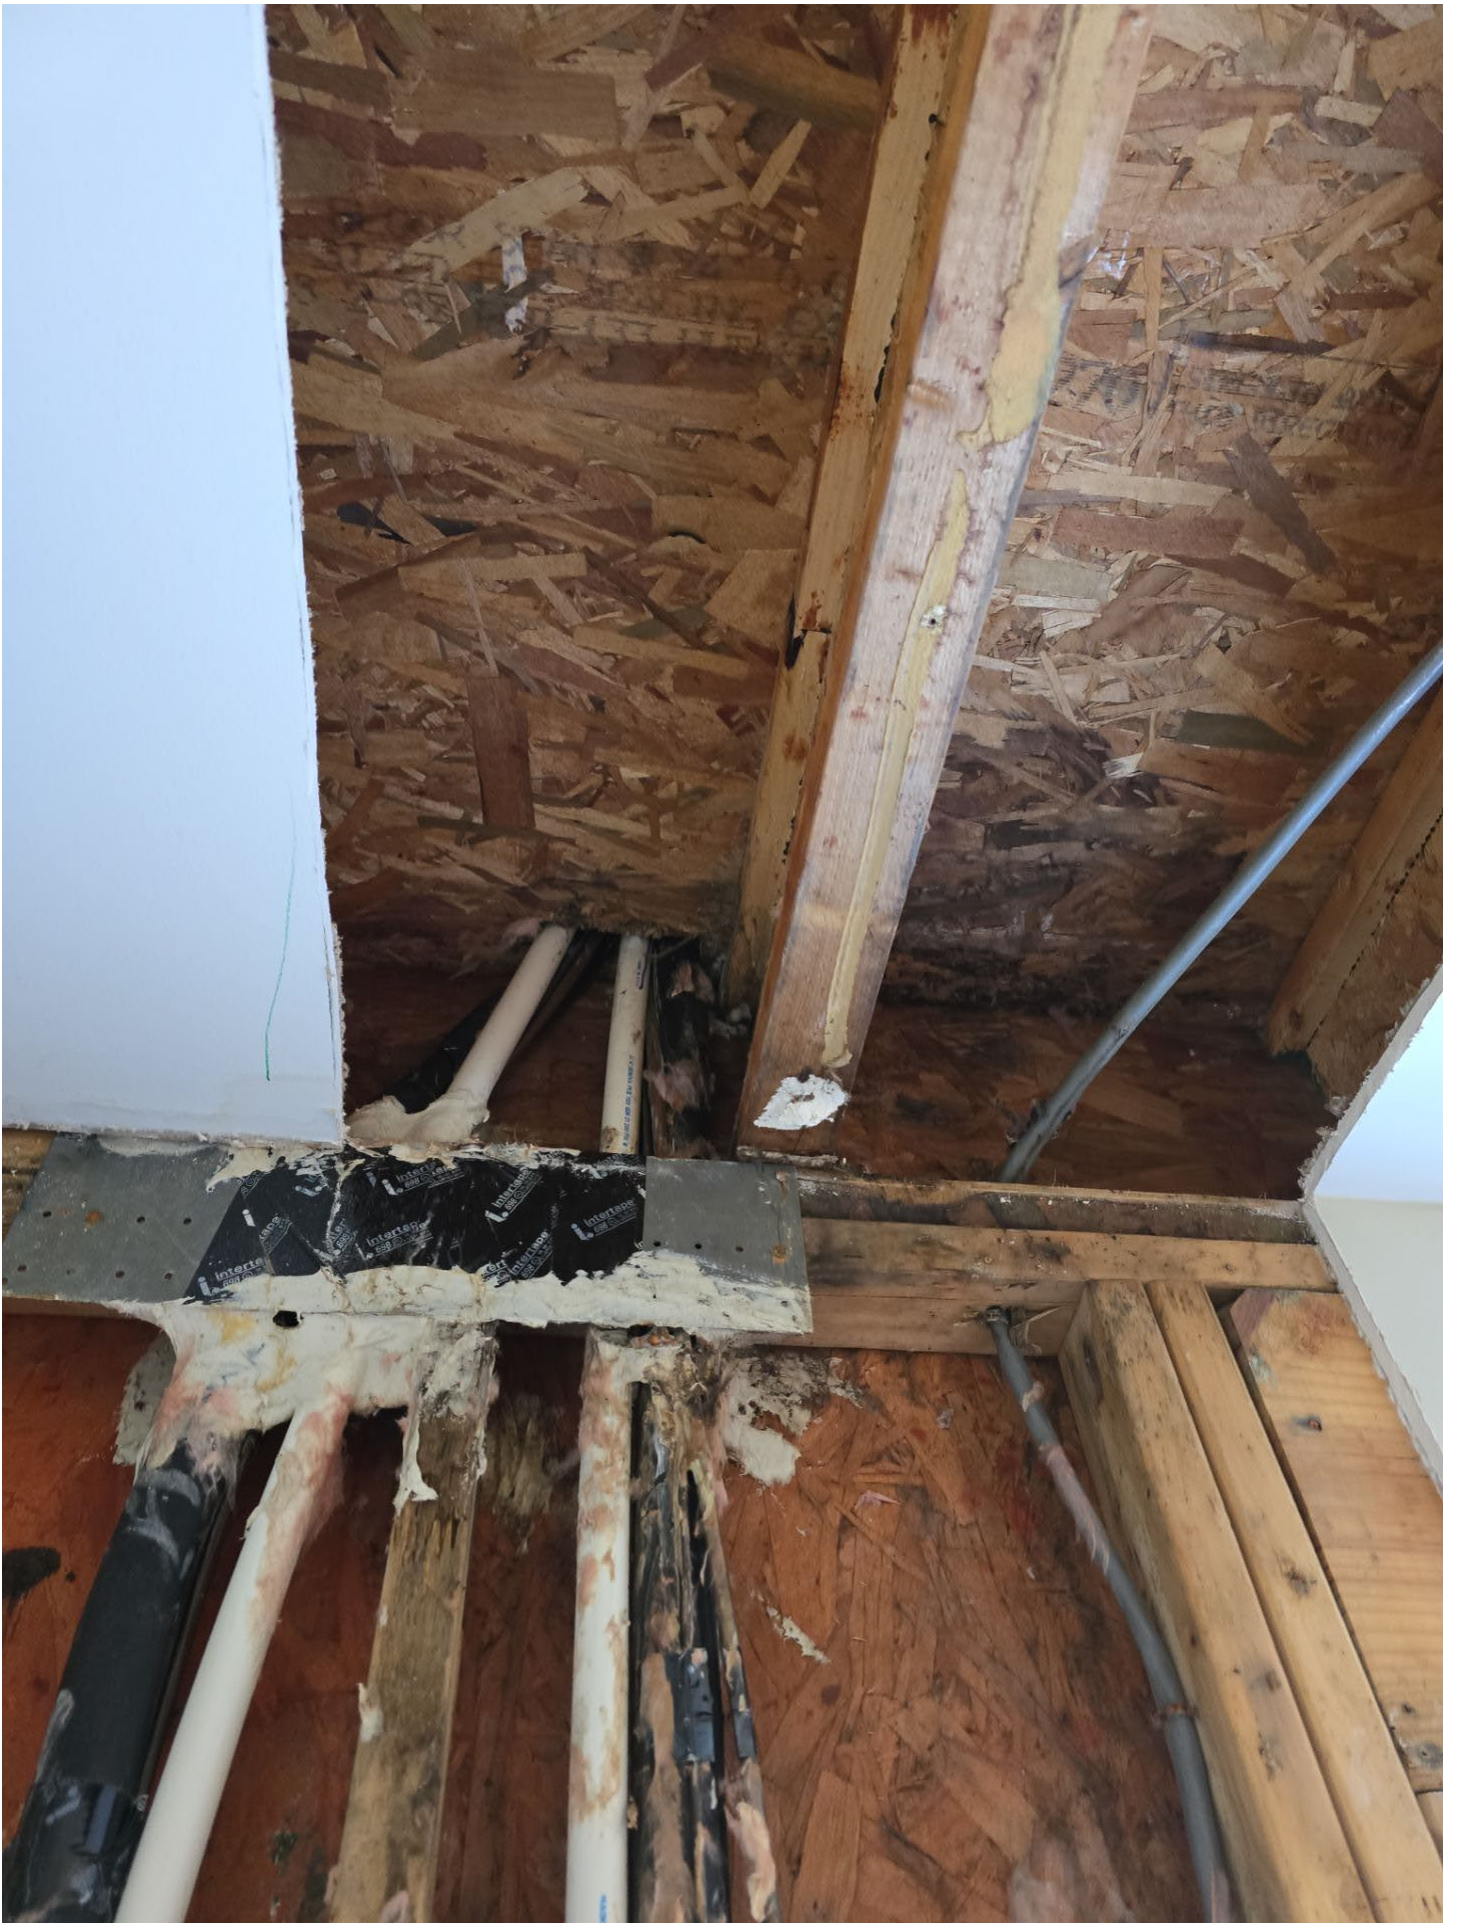
37.0% RH  
69.9°F

The structure should maintain the indoor dew point under 50 degrees Fahrenheit to control secondary sources of moisture. Recommended temperature acclimation would be in accordance to the IICRC psychrometric chart averaging 70 degrees Fahrenheit at 40 to 50 percent relative humidity to keep a low dew point.
